**Near Miss Investigation
Accident Prevention Analysis Program**

65th Street Incident

June 5, 2008

Sacramento Metropolitan Fire District

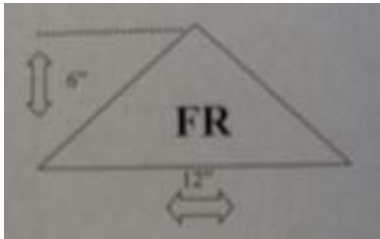
Example of a sign identifying a building with truss floor and roof construction.

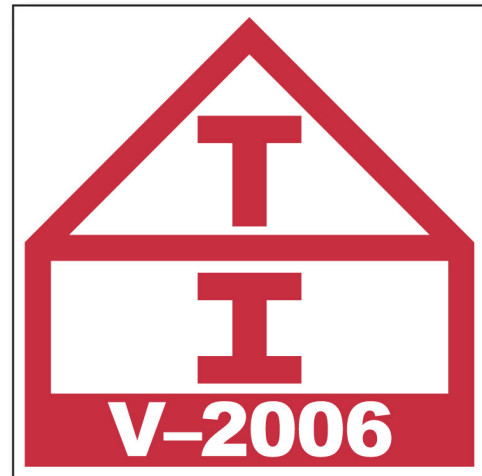
Figure 2

The construction type of the building's floors shall be indicated by placing the appropriate designating letter or letters in the lower portion of the diagram, and the construction type of the building's roof shall be indicated by placing the appropriate designating letter in the upper portion of the diagram, as shown in Figure 2. The designating letters shall be 2 inches (50.8 mm) minimum in height and have a stroke width of ½ inch (12.7 mm) minimum.
